**National Highway
Traffic Safety
Administration**

Case Vehicle (A): 2000 Buick
 Type: Regal GS, 4-door sedan
 Driver: 40-year-old male
 CDC: 12-FDEW-5

SITUATION

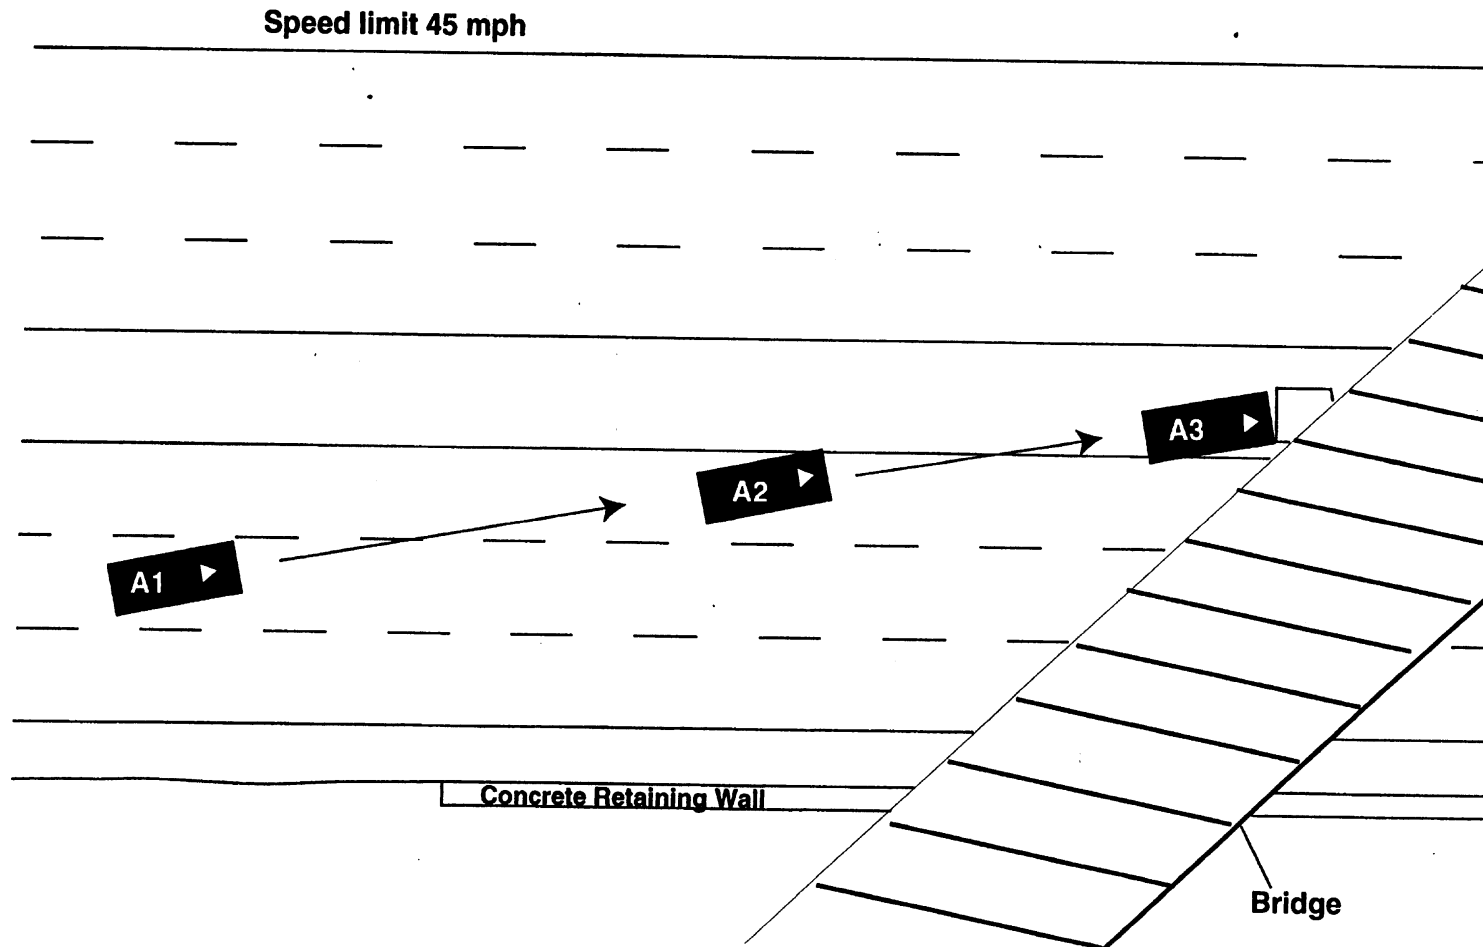
ACCIDENT SCHEMATIC

ACCIDENT DESCRIPTION: Case vehicle (A) was traveling north in the middle northbound lane of a straight section of a dry asphalt, six-lane divided roadway. For an unknown reason, the driver of

case vehicle (A) veered across the inside northbound lane, entered a concrete median with mountable curbs, and struck a bridge abutment head-on in a full frontal mode. After impact, case vehicle (A) rebounded away from the abutment and came to rest in the median facing north.

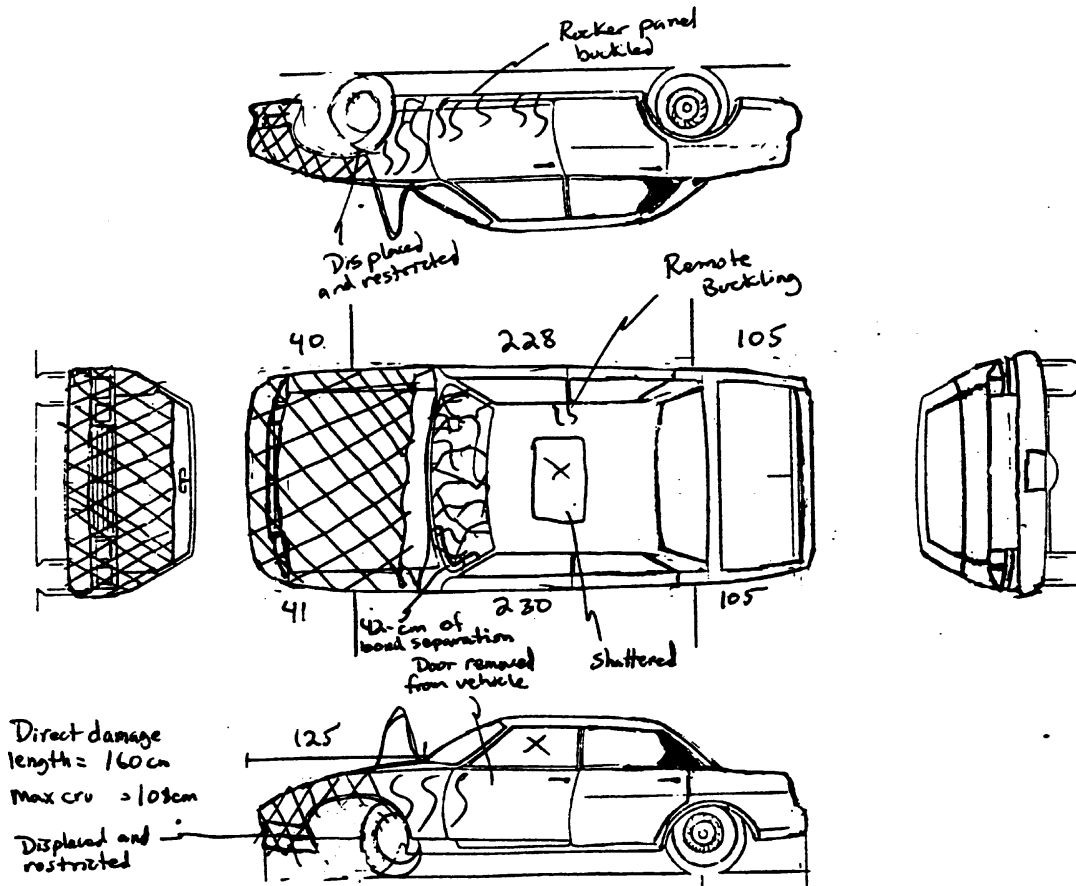
VEHICLE DAMAGE

(Slide 4) Damage to case vehicle (A) was severe. The direct-damage length was 160 cm and began at the right-front bumper corner. The maximum crush was 108 cm and occurred 54-cm inboard from the right-front bumper corner. The right wheelbase was reduced 49 cm, and the left wheelbase was reduced 47 cm.

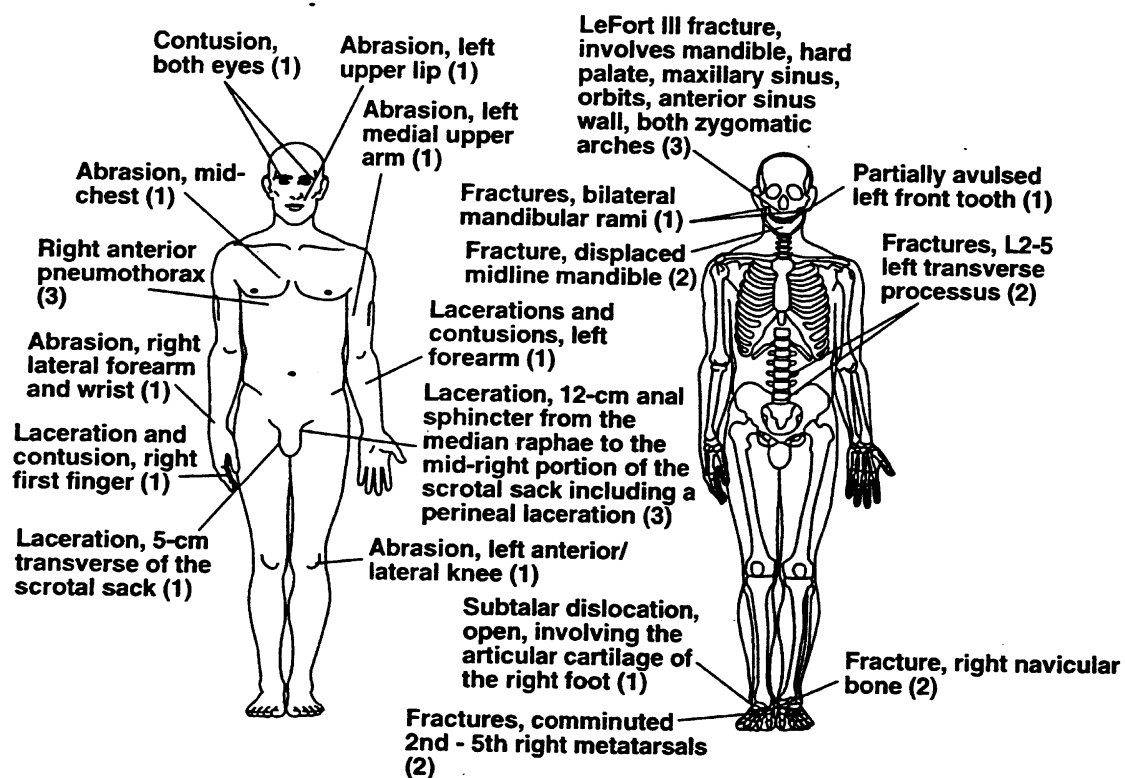
INDICATE LOCATION OF INJURIES.

appear that he made contact with the windshield header. He sustained contusions to both eyes and an abrasion to the left upper lip, probably from contact by the deploying airbag. He sustained a LeFort III fracture, involving the mandible, the hard palate, the maxillary sinus, the orbits, the anterior sinus wall, and both zygomatic arches. He also sustained fractures to the bilateral mandibular rami, a midline displaced fracture of the mandible, and a partially avulsed left-front tooth. These facial fractures were probably caused by contact with the steering-wheel rim through the overloaded airbag, and by contact with the upper instrument panel. He sustained a mid-chest abrasion and a right anterior pneumothorax from contact with the steering-wheel rim through the airbag. He sustained fractures of the left transverse process of L2 through L5, probably from twisting and rotation of his torso. (Slide 42) He sustained a 12-cm laceration to the anal sphincter, from the median raphe to the mid-right portion of the scrotal sack, involving a laceration to the perineum, and a 5-cm transverse laceration to the scrotal sack. These lacerations are probably from splaying of the buttocks as he loaded the seat, resulting in stretching and pulling of the scrotal area, but are possibly from direct contact with the instrument panel/knee bolster or the foot pedals.

He sustained abrasions to the right forearm and wrist, and a contusion and laceration to the 1st right finger, probably from contact with the instrument panel. He sustained lacerations to the left forearm, probably from flying glass, but possibly from contact with the instrument panel. He sustained contusions to the left forearm, probably from contact with the instrument panel, but possibly from contact with the interior surface of the door. He sustained an abrasion to the left medial upper arm, probably from contact by the deploying airbag. He sustained an abrasion to the anterior/lateral aspect of the left knee, probably from contact with the knee bolster. (Slides 43, 44, 45) He sustained an open subtalar dislocation, involving the articular cartilage of the right foot, a fracture of the right navicular bone, and comminuted fractures of the 2nd through 5th right metatarsals, probably from contact with the accelerator pedal/toe pan.
